### Abstract

# Houston Road Redesign

Abdullah Afridi<sup>1</sup>, Justin Graham<sup>1</sup>, and Amanda Stephenson<sup>1</sup>; Advisors: Dr. Nabil Al-Omaishi<sup>1</sup>, Dr. Thomas Brennan<sup>1</sup>, and Dr. Michael Horst<sup>1</sup> <sup>1</sup>Department of Civil Engineering, The College of New Jersey, Ewing, NJ

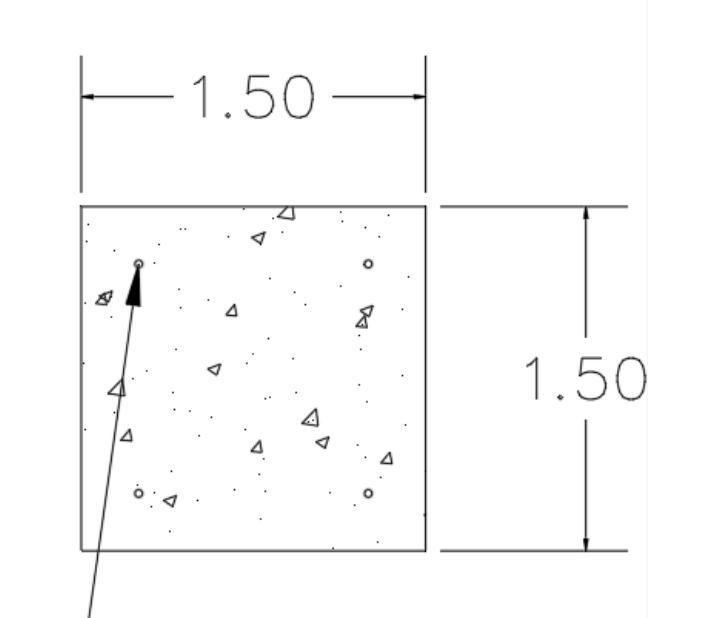
**Figure 3: Column Design**

#3 Rebar Typ.

Concrete Deck	4 ksi
Deck Dimensions	40'x8'x7"
Floorbeam	W8x15
Girder	W12x40
Column	18"x18"
Rebar	4 #3 Rebar

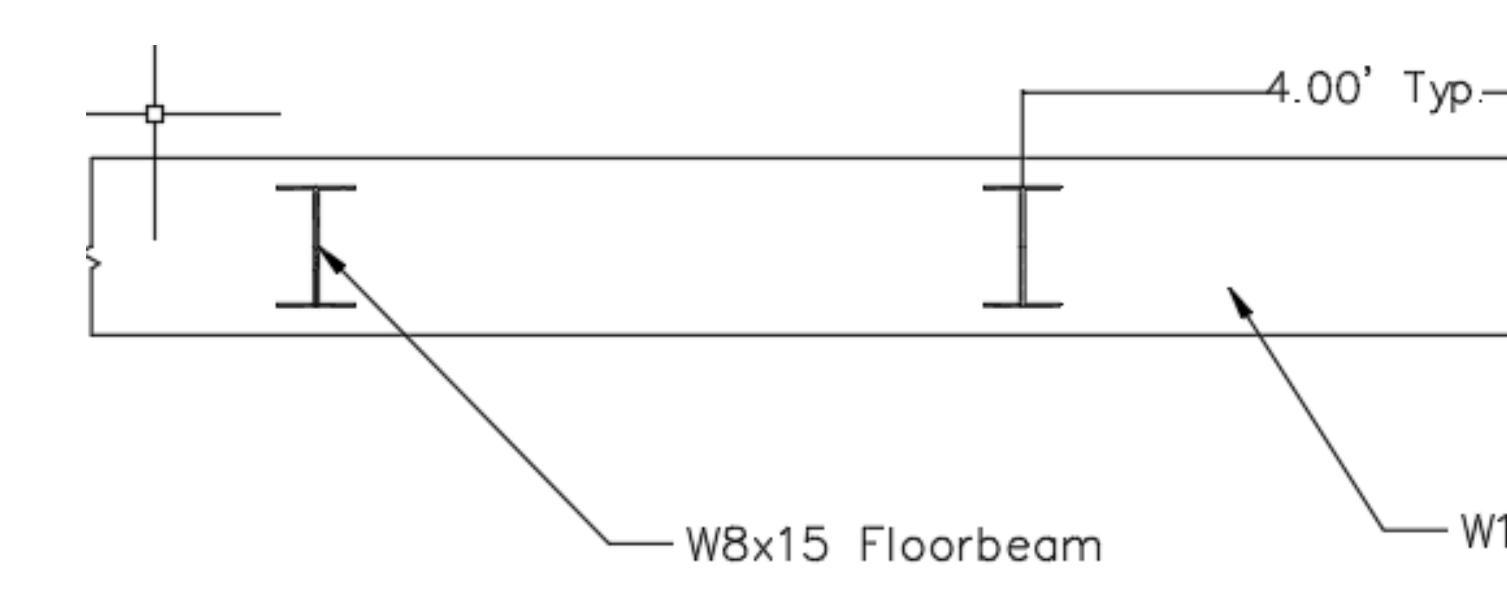
**Figure 4: Typical Floorbeam Layout**

-W12x40 Girder
